USAAEFA PROJECT NO. 78-18

**ARTIFICIAL ICING TEST CH-47C HELICOPTER
WITH FIBERGLASS ROTOR BLADES**

FINAL REPORT

JULY 1979

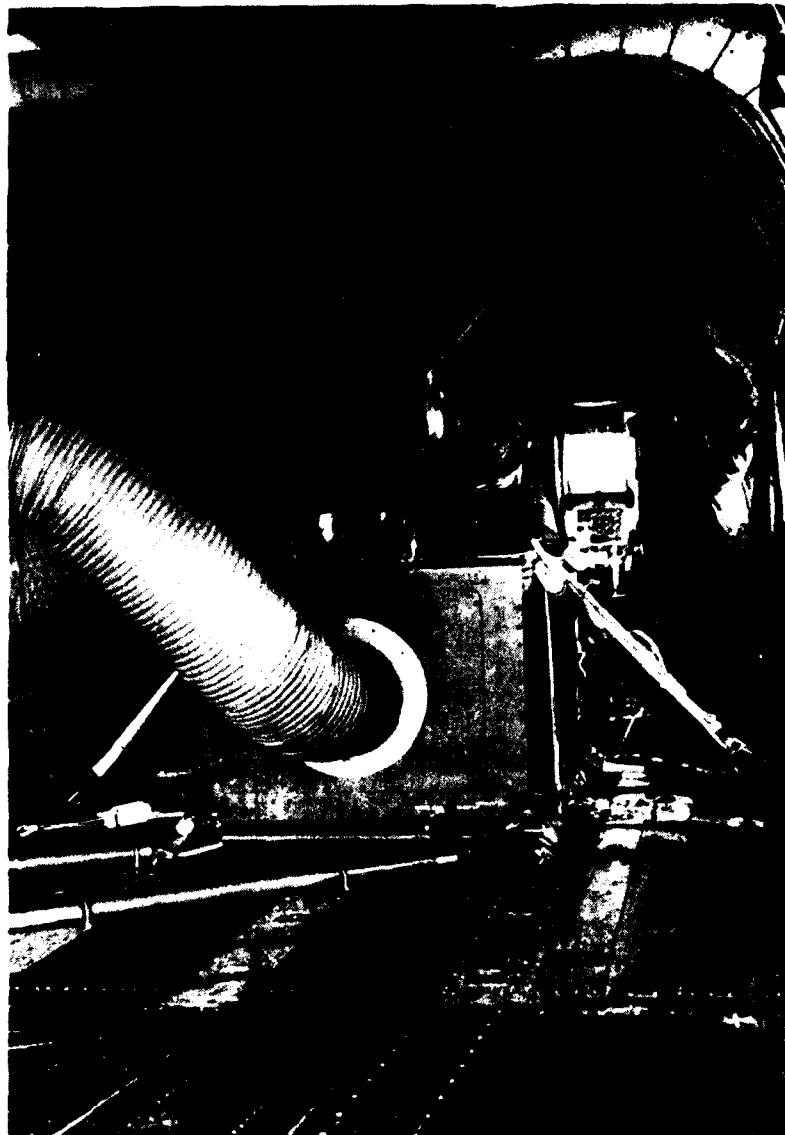
9. The cabin mounted, gas turbine driven generator set (FSN6115-075-1639 Air Research Model GTGE70-6-1) provided the source for blade de-ice electrical power (photo 3). The unit was intended for landing station ground support and was skid mounted. It was rated at 45KW at 120/208V, 3 phase, 4 wire to the system control and power distribution panel. The generator was installed between Sta. 360 and Sta. 440 and restrained in all axis by means of standard cargo tiedowns. The gas turbine air inlet was provided through two flexible inlet ducts mounted between a plenum added over the generator set inlet and two right hand side cabin windows. Gas turbine exhaust routing was through a stainless steel duct connected between the generator set exhausts and an aft right hand cabin window. Inlet leading edge fences were provided to minimize water and debris ingestion. The generator set fuel supply was provided from the left aux fuel tanks from a dip tube added at an existing fuel cell access hole. A breakaway filter was provided at the tank exit. A fuel shut off valve was provided in the tubing run to the generator set fuel inlet.

Photo 3. De-ice System Generator Installation.

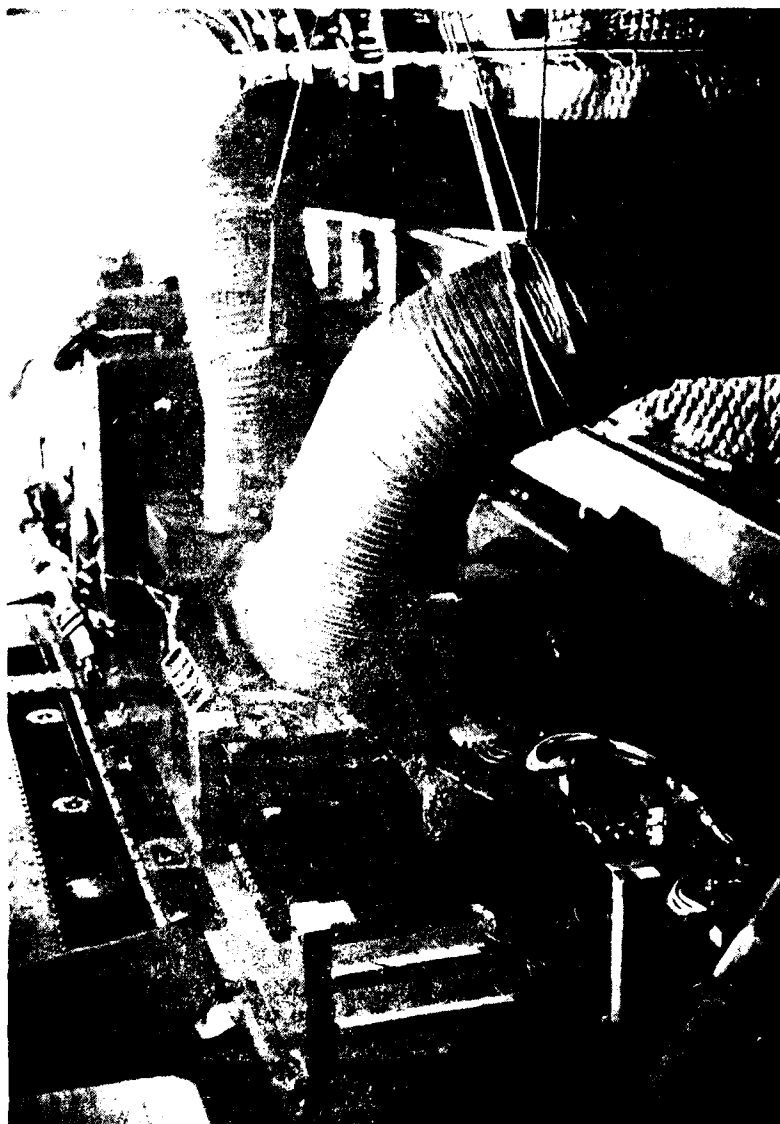
10. The de-ice system control and power distribution system was contained on a 3' x 5' pallet. The pallet was floor mounted between station 260 and 320 (photo 4). The basic system components mounted on the pallet included the controller, pulse counter and test box as well as auxiliary control switches and relays. The controller (B/V, P/N A02ES125-14) was supplied with both 115/200 volt AC and 28 VDC power. When a 28 VDC positive ice signal was received from the pulse counter, 200V, 400 hertz, 3 ϕ power was pulsed to the rotor blade heating elements. The 1st through 6th, 200 VAC pulses were fed to the fwd rotor power transfer unit. The 7th through 12th 200 VAC pulses were fed to the aft rotor power transfer unit. The controller always returned to the No. 1 position unless the system shut down during operation. The system OAT temperature sensor resistance unbalanced an internal bridge and determined the length of time each heater element would be energized. This time could be adjusted by means of the pulse on-time adjustment resistor. A dummy temperature sensor resistance was connected for ground test purposes and gave a simulated signal approximately equal to temperature of 30°F when the test switch was placed in the test position. The pulse counter (B/V, P/N A02ES172-1) received and counted the ice detector probe signals from the selected probe only. The third signal received was transferred to the controller to provide it with a 28 VDC positive ice signal. The test box (BV, P/N SK27789-1) was installed to provide a method for using the de-ice controller and to provide indicating lights for observation of system operation. The controller output pulses were connected to the test box for balanced loading while also being connected to relays for control of the 200 VAC power to the blade de-ice distributors.

Photo 4. De-ice System Monitor and Control Pallet.

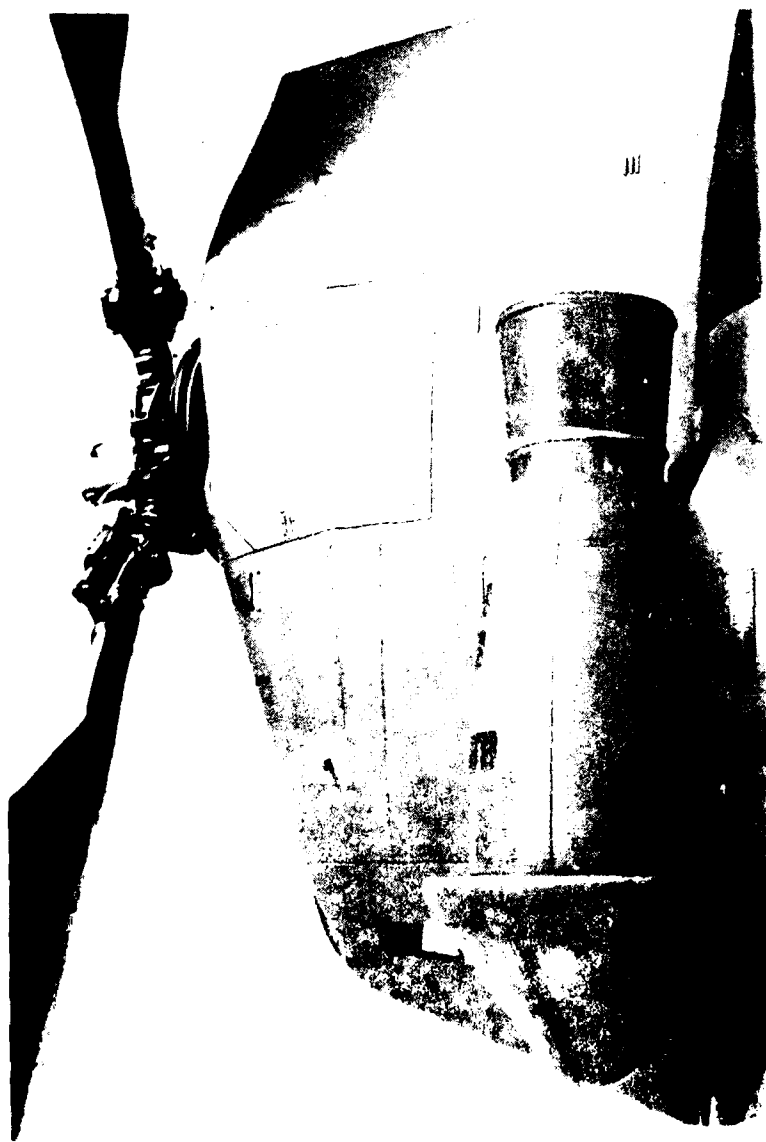
12. Ice detection was provided for the system through either the fwd pylon or aft pylon mounted Rosemount ice detectors (photos 5 and 6). Selection of the desired detector was by means of pallet-mounted selector switch. Ice detectors were located in pylon areas chosen (based on air flow and review of previous test data) to provide required icing correlation. The forward ice detector was located on the right side of the forward pylon at W.L.58, approximately 4 inches from the leading edge of the fairing (photo 5).

Photo 6. Aft Pylon Ice Detector.

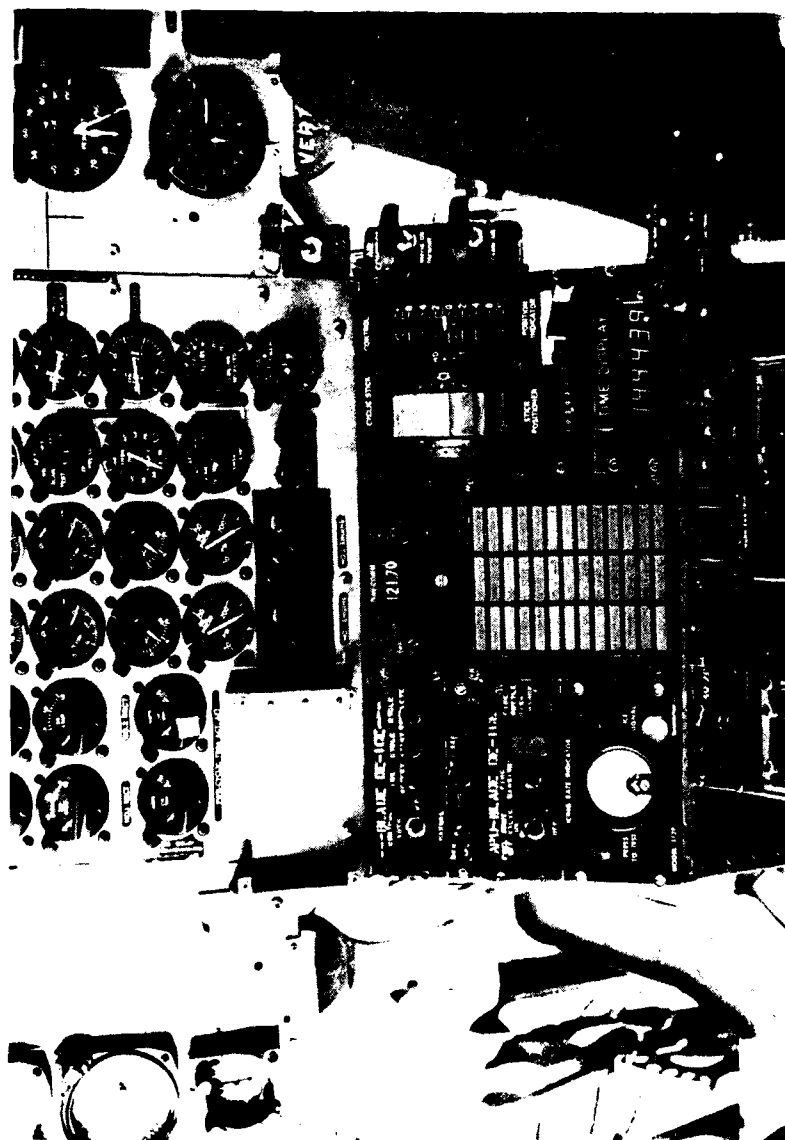
14. Cockpit displays and controls included de-ice auto/manual select switch, auxiliary power unit (APU), fuel shut off, APU fire bottle discharge switch, Rosemount ice accretion indicator and advisory lights to indicate: power on, ice detect (selected head), de-ice cycle start, de-ice cycle complete, and individual rotor system de-ice cycle pulses. System circuit breakers were also mounted in the cockpit (photo 7).

Photo 7. Cockpit De-ice System Display and Control Panel.
